# DIVER INSPECTION REPORT

River Hill HOA

82,000 ON-GRADE CONCRETE

Inspection Date: 02-17-2026

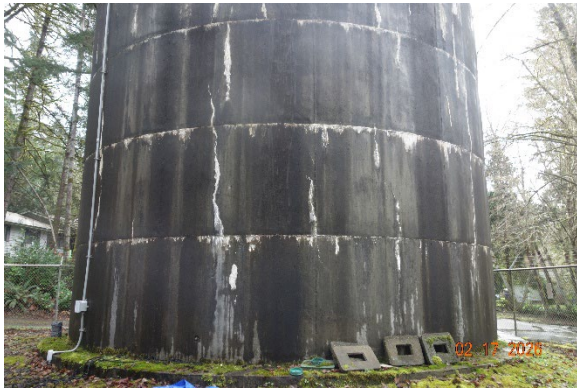
**(#1) Exterior/Foundation**

Exterior Concrete is in good condition. There are mineral deposits from past leaks, no active leaks were observed. Bio growth is present on the roof. **It is recommend to pressure wash the roof to remove the plant growth to prevent deterioration of the concrete beneath the growth.** (Image 1-10)

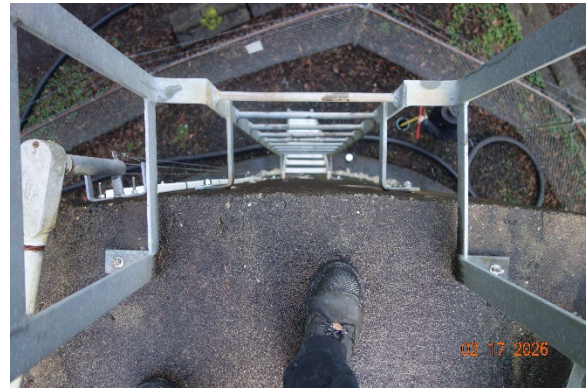
**(#4) Exterior Ladder**

Ladder and safety cable are in good condition. (Image 3-4)

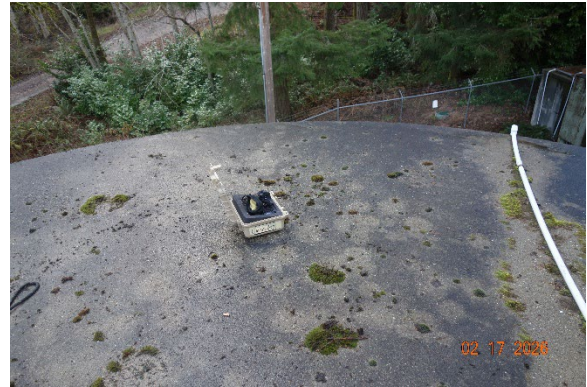
**(#5) Roof with Bio Growth**

1. Epoxy repair to the inlet and overflow to prevent deterioration of the cast section of pipe.
  2. Pressure wash the roof to remove bio growth from the roof to prevent deterioration of the concrete beneath those areas.
  3. Install (1) OSHA confined space entry placard to be placed on the roof access hatch.
- Special notes:

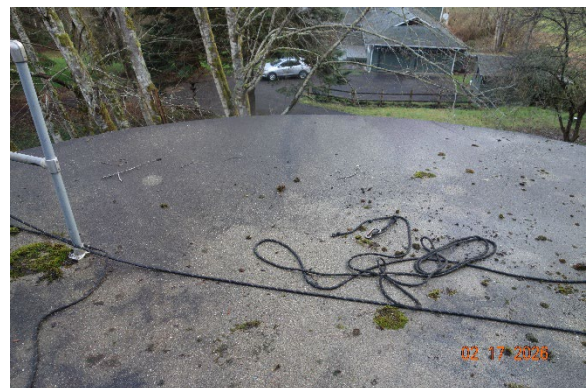
**(#6) Roof with Bio Growth**

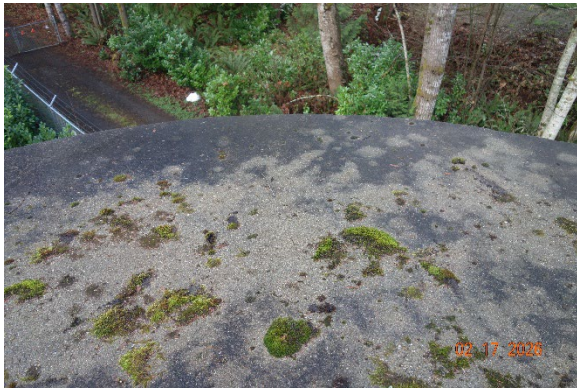
**(#7) Roof with Bio Growth**

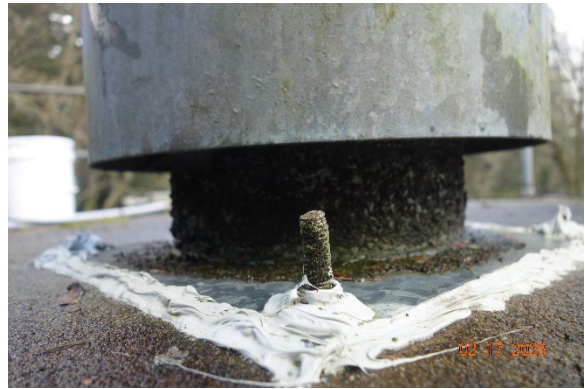
**(#10) Roof Vent**

The roof vent is in good condition. (Image 9-10)

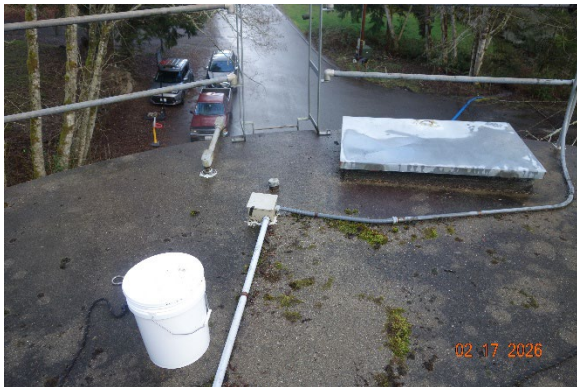
**(#8) Access Hatch**

Hatch and gasket are in good condition. (Image 8, 11-13)

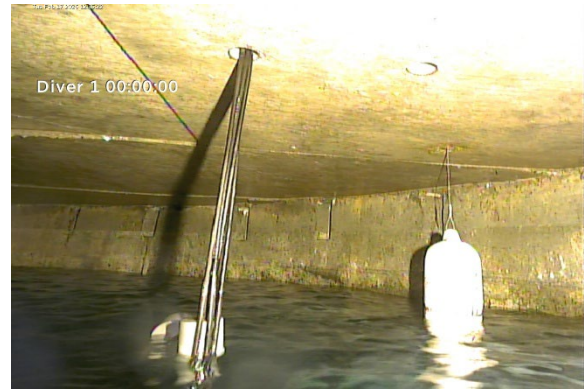
**(#16) Roof/Float**

The float assembly is in good condition and functioning properly. (Image 16-17)

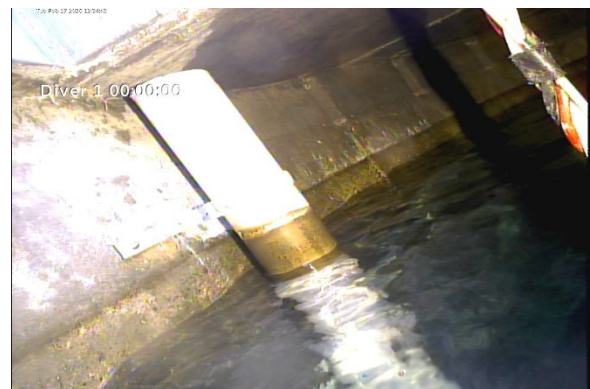
**(#18) Overflow**

Internal overflow is in good condition. There is some corrosion present on the cast section of the pipe and the clamp hardware. **Recommend epoxy repair to prevent further deterioration.** (Image 18-20, 32)

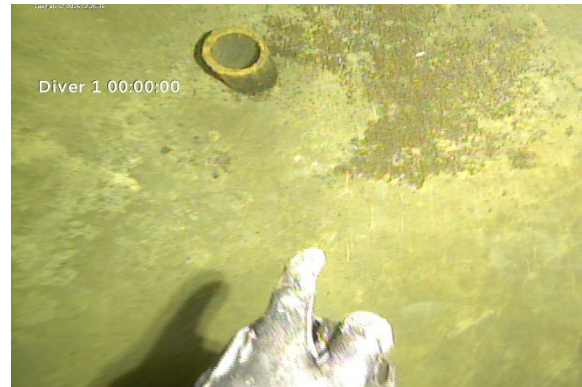
**(#22) Floor/Drain**

The inlet, outlet and drain are in good condition. There is some corrosion present on the drain and the cast section of the inlet as well as the clamp hardware of the inlet. **Recommend epoxy repair to prevent further deterioration.** (Image 21-23, 33)

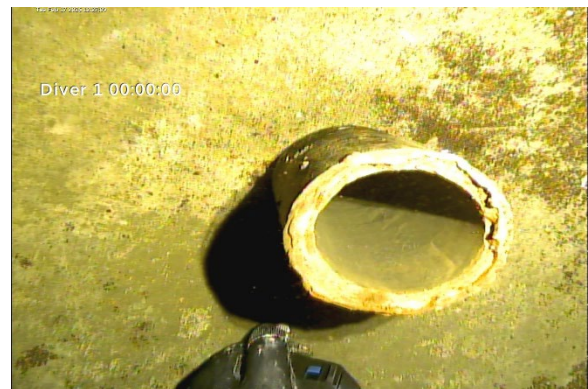
**(#23) Drain with Rust Nodules**

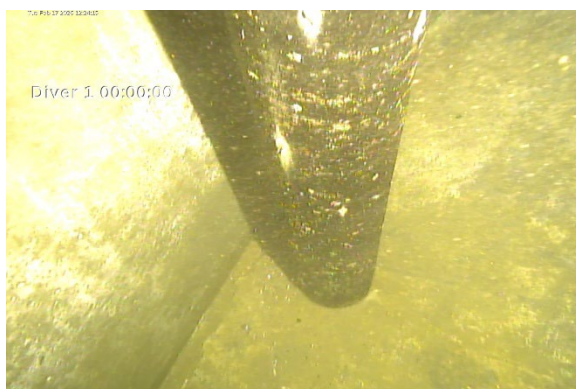
**(#21) Inlet Pipe with Rust Nodules**

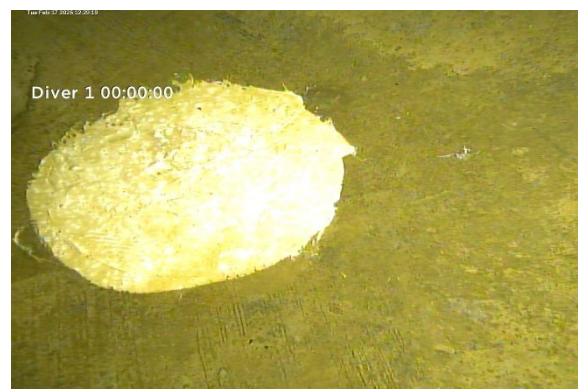
The tank floor is in good condition. The past epoxy repair near the drain is in good condition with no tearing or cracking visible. (Image 24, 29-30)

**(#24) Previous Epoxy Floor Repair**

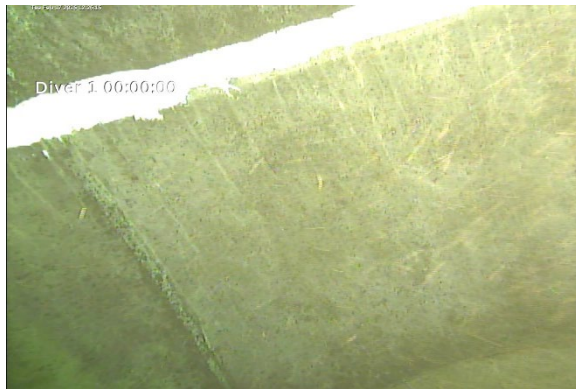
**(#25) Wall/Course Repair**

Interior walls are in good condition. The past epoxy repairs on the course seams are in good condition with no tearing or cracking visible. (Image 25-28)

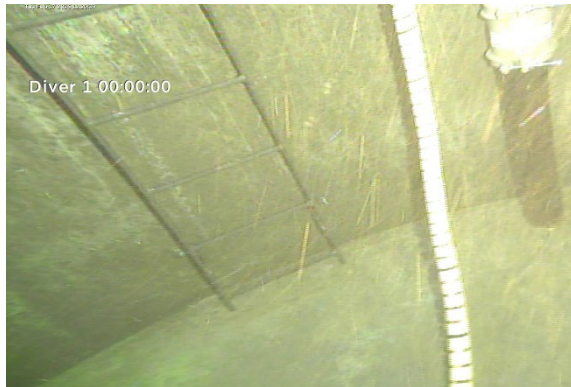
**(#31) Interior Ladder**

Ladder is in good condition. (Image 31-32)

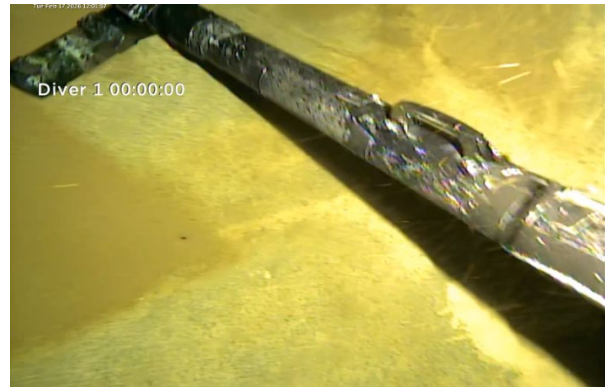
**(#34) Sediment Removal**

Cleaning/removal of sediment and loose floor debris were performed. No other repairs were provided at this time. (Image 34-36)
